Monroe County, 30 acres

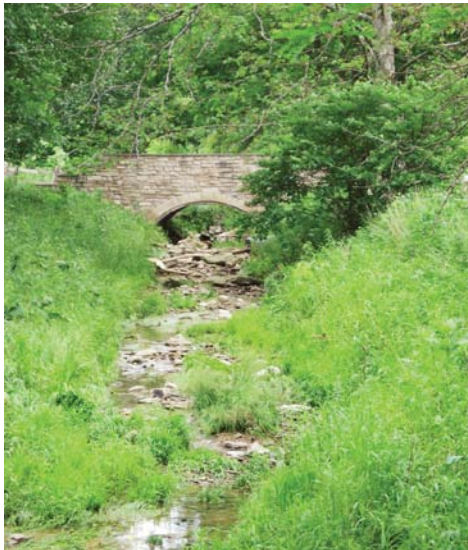
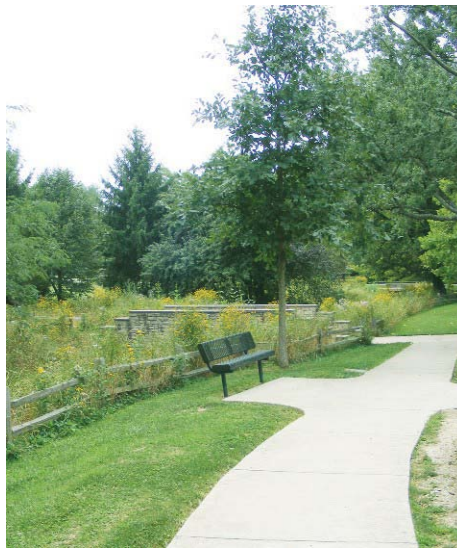
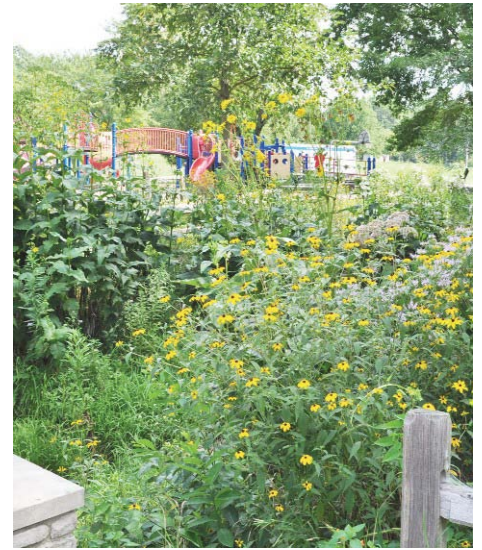
In the past, Bryan Park Stream was receiving intense storm water pressure, which was starting to cause significant erosion. In 2002, Eco Logic designed and installed a stream bank naturalization plan for Bryan Park Stream. The design addressed eroded stream banks and the desire to enhance water quality, reduce maintenance and add visual interest to the park. In 2009 and 2010 the stream received heavy high water flows and the native vegetation was able to hold the banks.

Native wet mesic grasses, sedges, rushes, and wildflower plugs were installed through coconut fiber erosion control blankets. Coconut fiber logs vegetated with wetland plants were used to control erosion around the culverts.

The native wildflowers attract songbirds and butterflies, providing not only habitat but exciting wildlife viewing experiences for park visitors. Some species that thrive on this site are Blue Flag Iris, Cup Plant, Joe-pye Weed, Wild Bergamot, and New England Aster.
